M 1059/81

1059. Bendix. Käynnistinvibraattorin korjaus

**SUBJECT :** Repair of certain starting vibrators utilizing "5" contact bushing (connector).

**SERVICE BULLETIN NO. 614**  
Engineering Aspects  
are FAA Approved

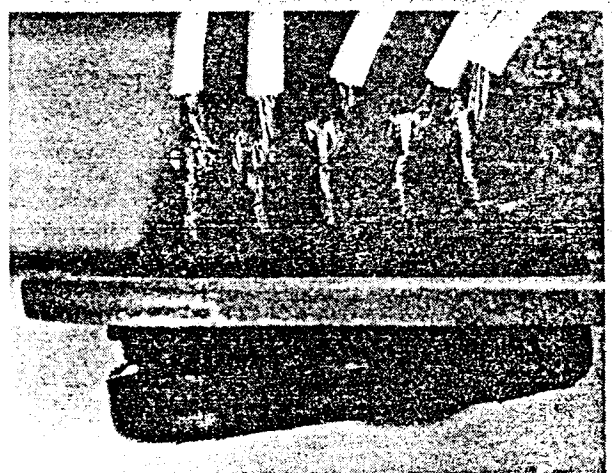
Figure 1 Defect

Bushing (connector), P/N 10-382943, may become loose in the vibrator plate and cause the grounding of both magnetos with possible loss of ignition. See figure 1 (defect).

1. Remove starting vibrator from the airframe.
2. Remove cover to expose the internal surface of the terminal bushing (connector).
3. The surface around the terminal bushing must be clean, dry, free of oil, dirt and grease.
4. Reseat the terminal bushing in the mounting plate to its full extent.
