**MUUTOSMÄÄRÄYS**  
**AIRWORTHINESS**  
**DIRECTIVE**

M 1357/86

1357. SST/Racer

# NOTICE TO OWNERS OF ALL SST/RACERS PURCHASED IN 1984 AND 1985

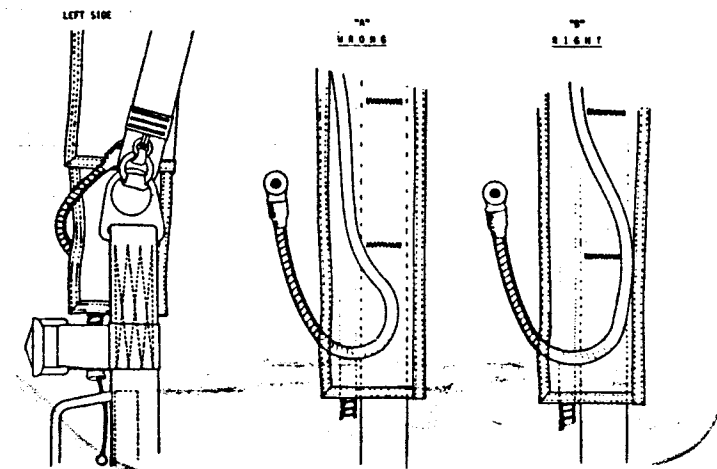
The left Three Ring release housing on some 1984-85 SST/Racers may be routed incorrectly. This deviation has no safety implications. Only appearance is affected as the incorrectly routed housing tends to push the left riser off the shoulder.

To identify whether your rig is affected, locate the left-over the shoulder comfort pad and trace the three ring housing to where it emerges from the pad on its way to the riser. Now reverse your trace and feel with your fingers whether the routing is as in sketch 'A' or 'B'. If it is as in sketch 'A' follow one of the corrective procedures as described below.

1. Remove the tacking and reroute the housing in the correct manner. Retack the housing. This method takes longer but does not require the use of a sewing machine.
2. Remove the lower 308 stitch holding the comfort pad to the type 8 diagonal. Move the housing to the outside of the pad and restitch. The restitch may be a 304 stitch if a 308 machine is not available.

NOTE: The proper distance for the housing to stick out of the pad is 4.5" to the centre of the eye for standard rings and 3.75 for mini rings.
