AIRWORTHINESS DIRECTIVE

M 1709/90

British Aerospace. Ohjaussauvan kahvan tarkastus.

FLYING CONTROLS - FAILURE OF HANDGRIP FITTING ON CONTROL COLUMN

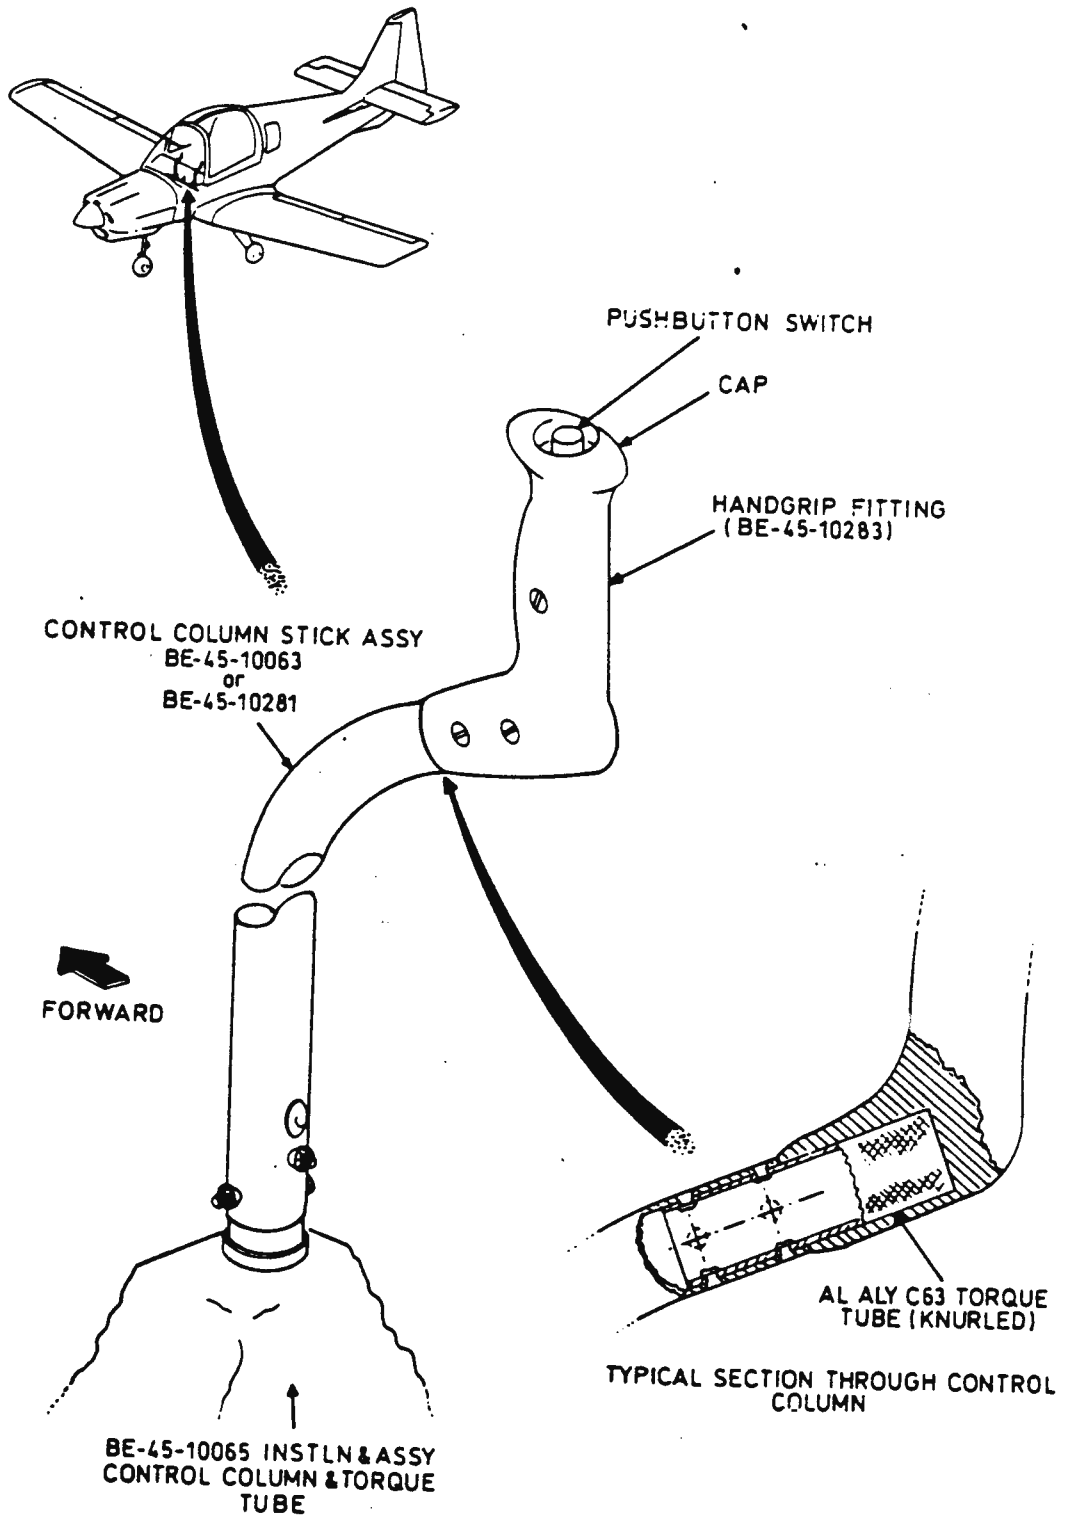
FIGURE 1

(a) Refer to Figure 1 and fit a suitable Tyrap, or equivalent
as close to the top of the handgrip as possible, for the
hook of the spring balance to locate on. Position the
hook of the spring balance on the handgrip and, using a
rope on the opposite end, apply a load of 35lb +/- 5lb
towards the left hand side of the cockpit, simulating
aileron control loading. While the load is being applied
visually inspect the handgrips for cracking, crazing,
distortion or other surface damage, using a strong light
and magnifying glass as necessary.

HANDGRIP FITTING AND CONTROL COLUMN
